# Manhole Inspection Summary

Manhole # S25KK1011MH

Insp Date: **11/6/06 1:53 PM**

**Location** Address: **1018 ROLAND HEIGHTS AVE**

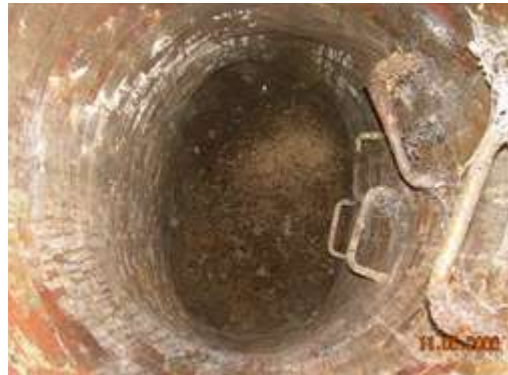
Top View

☒ **Debris** (not Condition related)

Count: **5** Missing: **0** ☒ **Corroded**

Corroded steps. Channel debris.

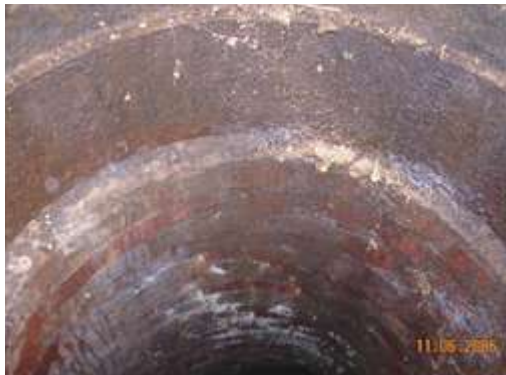
Defect

☒ **Leaks**

Infiltration: ☐ None ☒ **Joint** ☐ Cracks ☐ Mortar ☐ Roots ☐ Wall

Frame leaks. Adjustment infiltration.

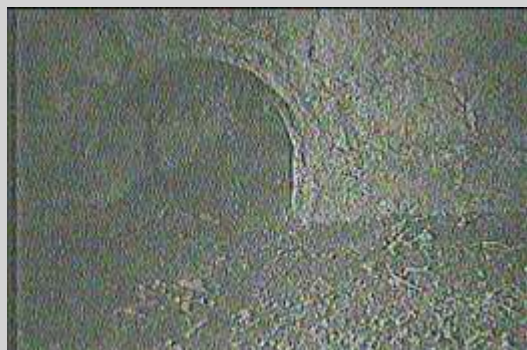
Pipe Out @ 12 O'Clock

8 in. Circular Gravity Sewer

Deposits: ☐ None ☒ **Mud** ☐ Sludge ☒ **Debris** ☐ Grease

Silt Depth: **1** (in.)

Deposits Extent: **Light**
